**Flood Control Project Maintenance
Levee Inspections**

Fall 2013 Levee Maintenance Deficiency Summary Report

Sacramento River Basin

ST0003	Overall LMA Rating	Total LMA Miles						
Sutter Maintenance Yard East Levee Sacramento River	A	27.17						
Rated Item	Maintenance Deficiency				Enforcement		Design & System Obsolescence	
	M Miles	U Miles	M + 4U Miles	Threshold %	M Miles	U Miles	M Miles	U Miles
<i>Earthen Levee</i>								
Vegetation	0.04		0.04	0.15%	0.01			
Trim / Thin Trees	0.01		0.01	0.04%				
Encroachments	0.25		0.25	0.92%	0.51	0.28		
Animal Control	0.01		0.01	0.04%				
Slope Stability	0.02		0.02	0.07%				
Erosion / Bank Caving	0.20		0.20	0.74%				
<i>Supplemental</i>								
USACE Erosion Survey	0.07		0.07	0.26%				
DWR UCIP Field Study					0.42	0.58		
<i>LMA Totals:</i>	0.60	0.00	0.60	2.21%	0.94	0.86	0.00	0.00

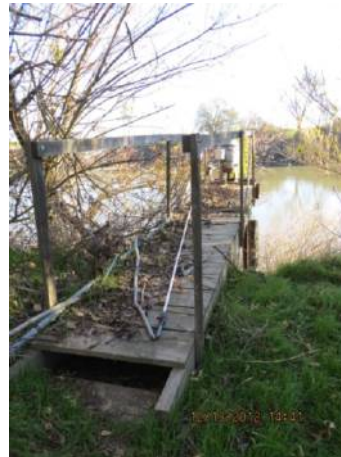
Levee Mile Report Line	9
Start Levee Mile	1.11
End Levee Mile	1.11
Location	Water Side
Category	Supplemental
Item	DWR UCIP Field Study

Waterside view: overview of walkway and pump

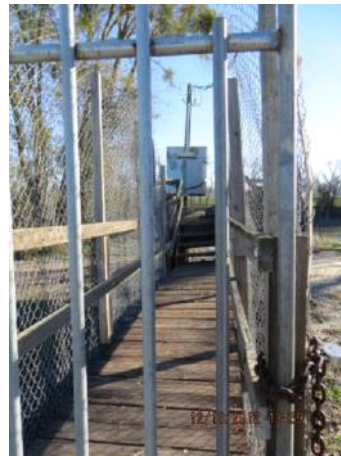
Levee Mile Report Line	17
Start Levee Mile	1.85
End Levee Mile	1.85
Location	Water Side
Category	Supplemental
Item	DWR UCIP Field Study

Waterside view: abandoned pump station and walkway

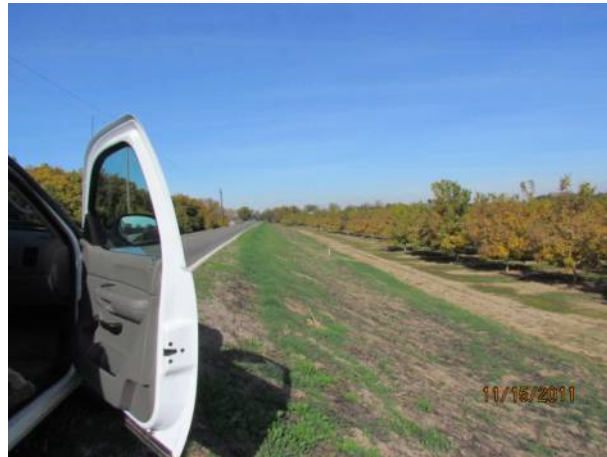
Levee Mile Report Line	20
Start Levee Mile	3.06
End Levee Mile	3.12
Location	Land Side
Category	Earthen Levee
Item	Animal Control

View of the rodent holes & bait station.

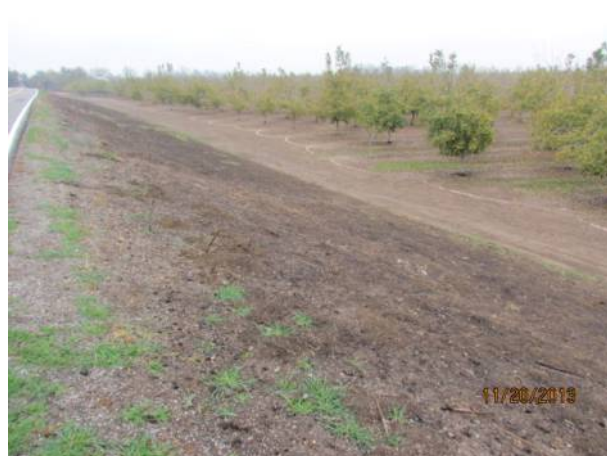
Levee Mile Report Line	20
Start Levee Mile	3.06
End Levee Mile	3.12
Location	Land Side
Category	Earthen Levee
Item	Animal Control

View of the grouted rodent holes.

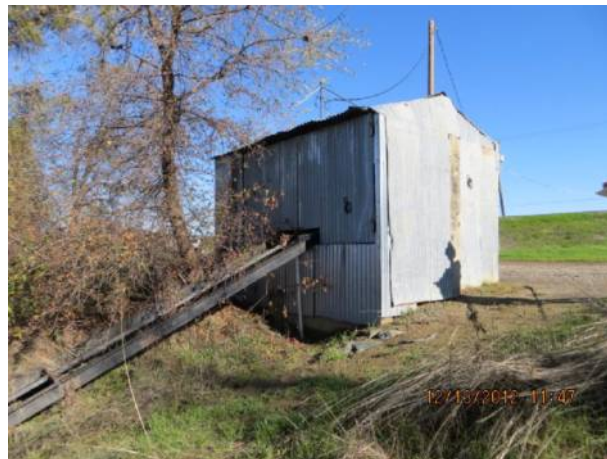
Levee Mile Report Line	28
Start Levee Mile	3.79
End Levee Mile	3.79
Location	Water Side
Category	Supplemental
Item	DWR UCIP Field Study

Waterside view: overview of pipe and pump house

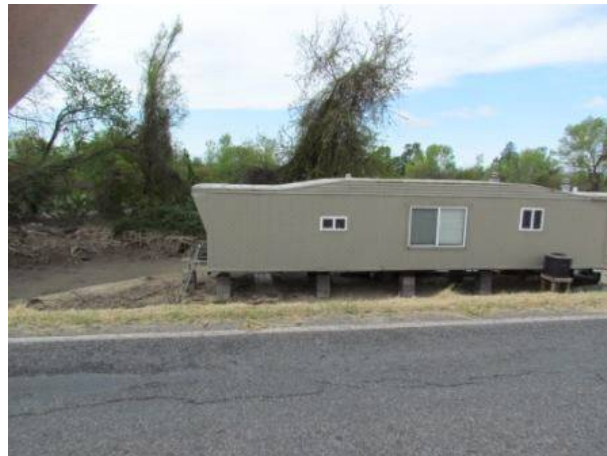
Levee Mile Report Line	35
Start Levee Mile	4.19
End Levee Mile	4.19
Location	Water Side
Category	Earthen Levee
Item	Encroachments

View of the trailer next to the W/S toe.

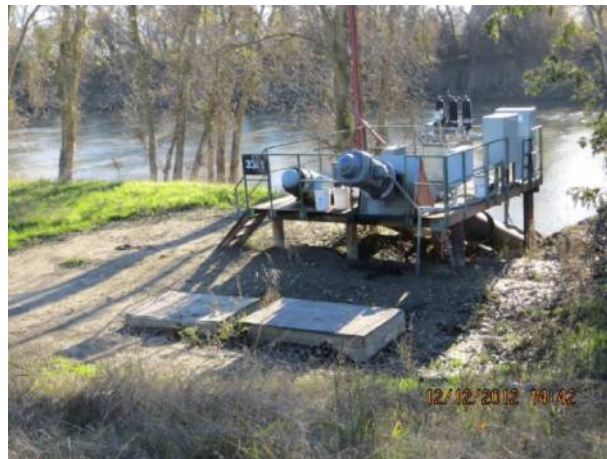
Levee Mile Report Line	51
Start Levee Mile	4.59
End Levee Mile	4.59
Location	Water Side
Category	Supplemental
Item	DWR UCIP Field Study

Waterside view: overview of pump station

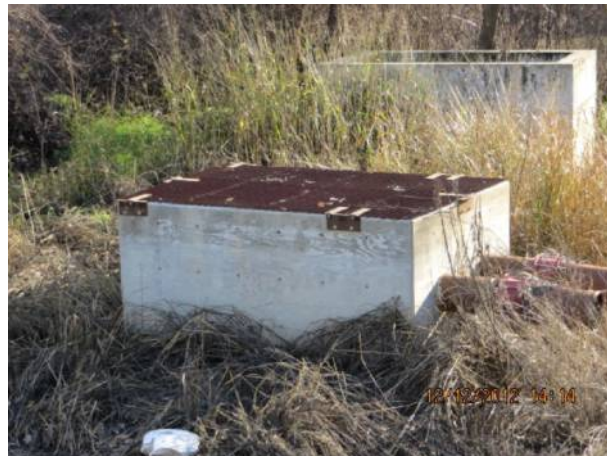
Levee Mile Report Line	61
Start Levee Mile	4.99
End Levee Mile	4.99
Location	Land Side
Category	Supplemental
Item	DWR UCIP Field Study

Waterside view: closer look at surge box

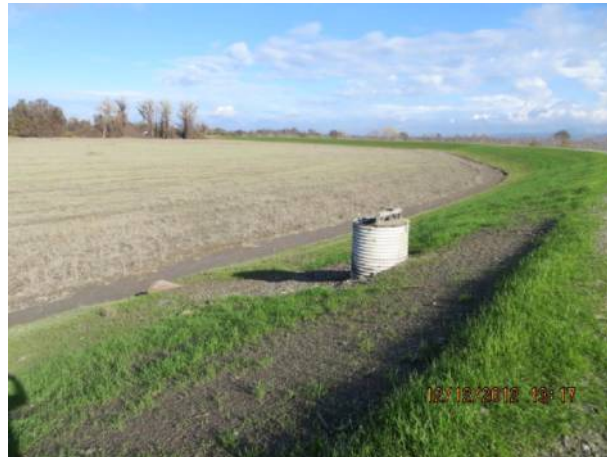
Levee Mile Report Line	65
Start Levee Mile	6.02
End Levee Mile	6.02
Location	Land Side
Category	Supplemental
Item	DWR UCIP Field Study

Waterside view: overview

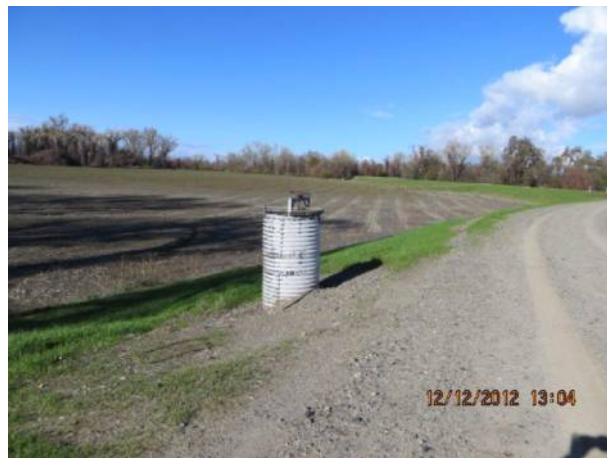
Levee Mile Report Line	67
Start Levee Mile	6.34
End Levee Mile	6.34
Location	Land Side
Category	Supplemental
Item	DWR UCIP Field Study

Waterside view: CMP riser with slide gate

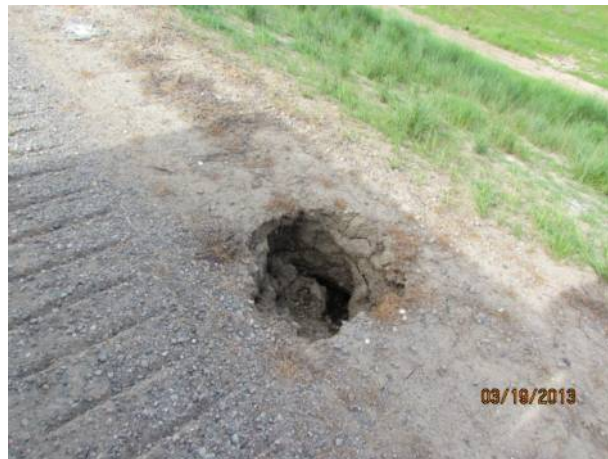
Levee Mile Report Line	72
Start Levee Mile	6.80
End Levee Mile	6.80
Location	Water Side
Category	Earthen Levee
Item	Erosion / Bank Caving

Erosion along the waterside crown.

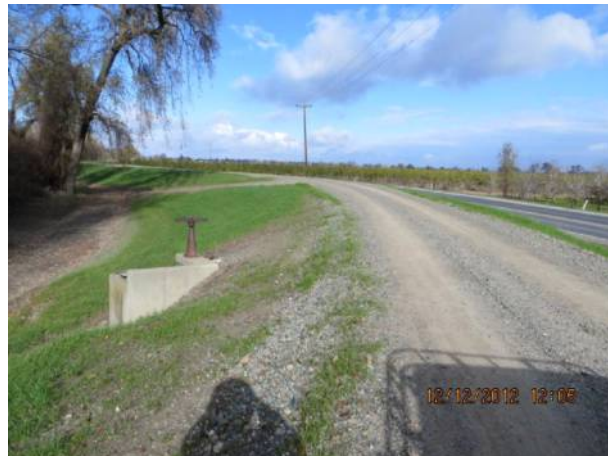
Levee Mile Report Line	73
Start Levee Mile	7.72
End Levee Mile	7.72
Location	Water Side
Category	Supplemental
Item	DWR UCIP Field Study

Waterside view: concrete box with slide gate

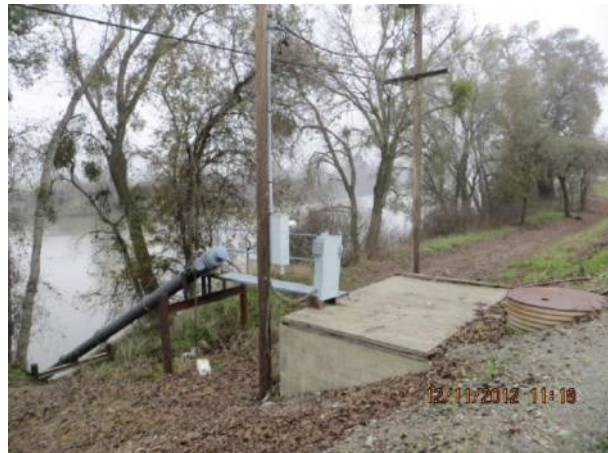
Levee Mile Report Line	93
Start Levee Mile	12.06
End Levee Mile	12.06
Location	Water Side
Category	Supplemental
Item	DWR UCIP Field Study

Waterside view: steel pipe, pump, surge box & CMP riser

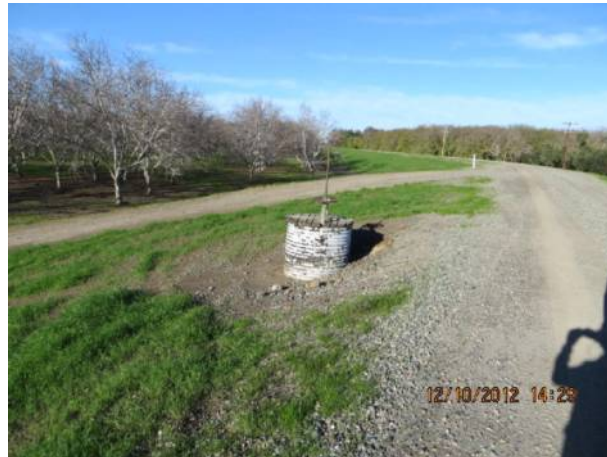
Levee Mile Report Line	102
Start Levee Mile	12.96
End Levee Mile	12.96
Location	Water Side
Category	Supplemental
Item	DWR UCIP Field Study

Waterside view: CMP riser on levee slope.

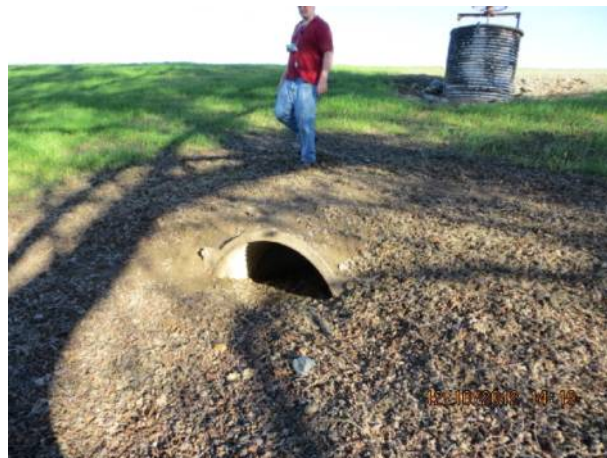
Levee Mile Report Line	107
Start Levee Mile	13.37
End Levee Mile	13.37
Location	Water Side
Category	Supplemental
Item	DWR UCIP Field Study

Waterside view: overview of CMP riser and outlet pipe

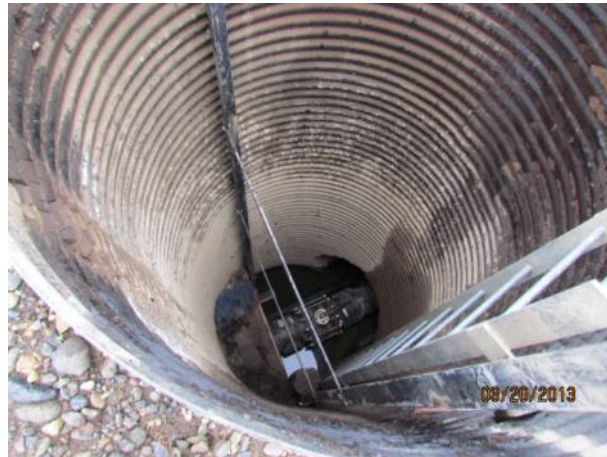
Levee Mile Report Line	113
Start Levee Mile	14.55
End Levee Mile	14.55
Location	Water Side
Category	Earthen Levee
Item	Encroachments

View of the unauthorized pipe placed inside the drain pipe.

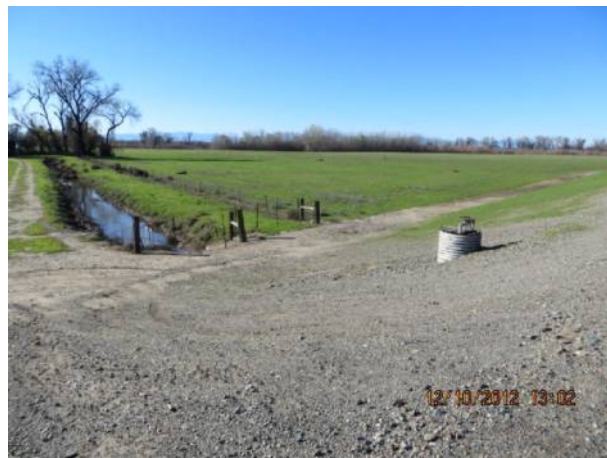
Levee Mile Report Line	114
Start Levee Mile	15.47
End Levee Mile	15.47
Location	Water Side
Category	Supplemental
Item	DWR UCIP Field Study

Waterside view: CMP riser, inlet box and water transfer ditch

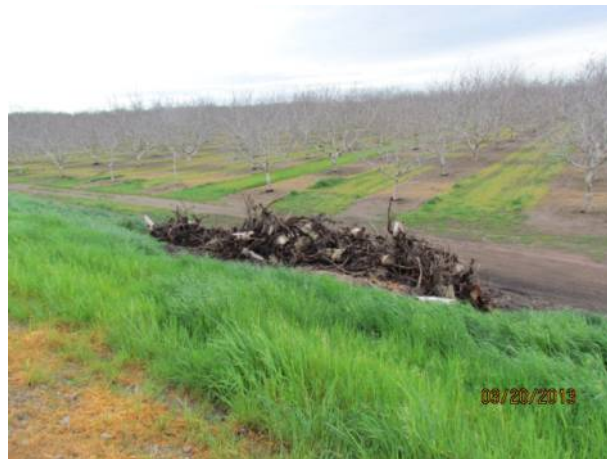
Levee Mile Report Line	118
Start Levee Mile	17.44
End Levee Mile	17.44
Location	Land Side
Category	Earthen Levee
Item	Encroachments

View of the walnut orchard stumps along the landside toe.

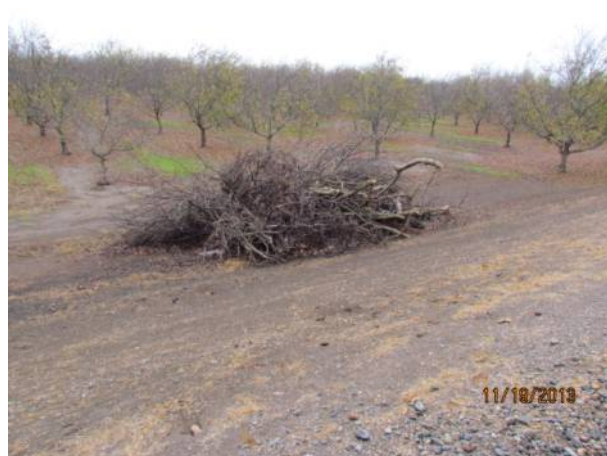
Levee Mile Report Line	119
Start Levee Mile	17.45
End Levee Mile	17.45
Location	Land Side
Category	Earthen Levee
Item	Encroachments

View of the prunings at the toe of the levee.

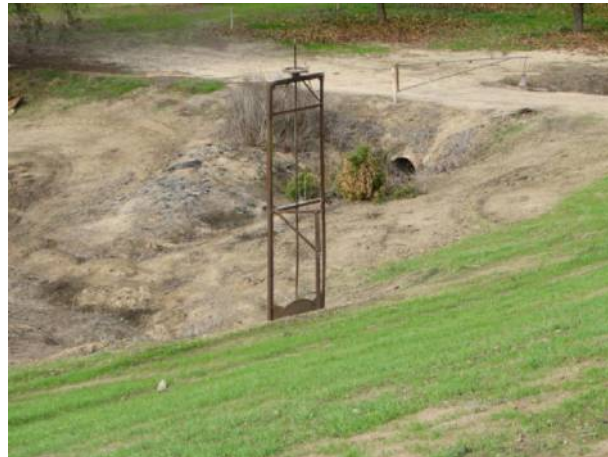
Levee Mile Report Line	124
Start Levee Mile	18.65
End Levee Mile	18.65
Location	Land Side
Category	Supplemental
Item	DWR UCIP Field Study

Waterside view: overview of sliding gate structure

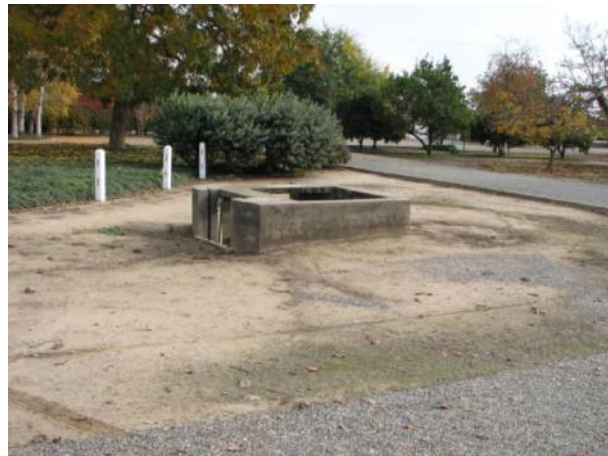
Levee Mile Report Line	128
Start Levee Mile	18.74
End Levee Mile	18.74
Location	Land Side
Category	Supplemental
Item	DWR UCIP Field Study

Landside view: overview of inlet structure

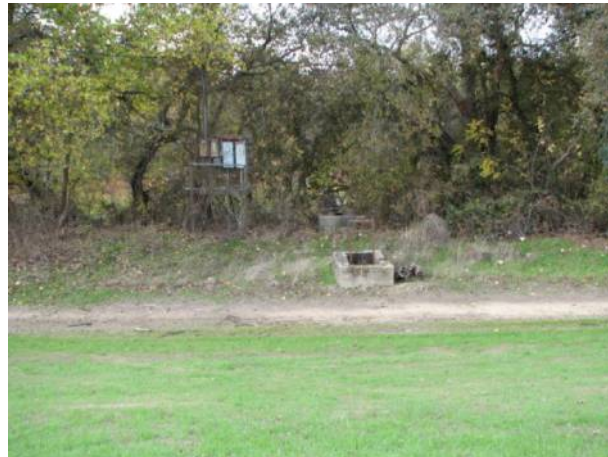
Levee Mile Report Line	135
Start Levee Mile	20.04
End Levee Mile	20.04
Location	Land Side
Category	Supplemental
Item	DWR UCIP Field Study

Waterside view: overview

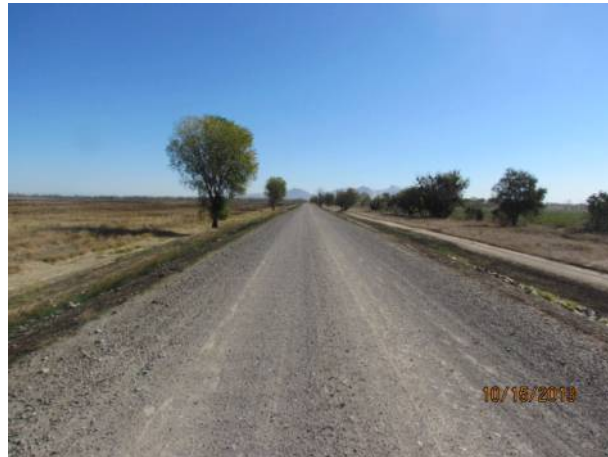
Levee Mile Report Line	2
Start Levee Mile	0.45
End Levee Mile	0.45
Location	Land Side
Category	Earthen Levee
Item	Vegetation

Sutter Yard burned both slopes of the levee.

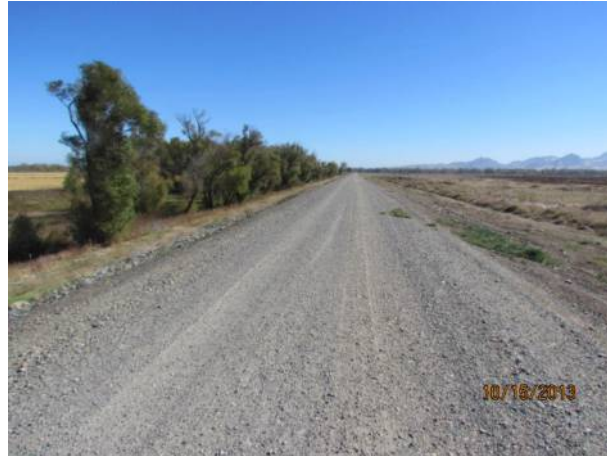
Sutter Yard burned both sides of the levee.

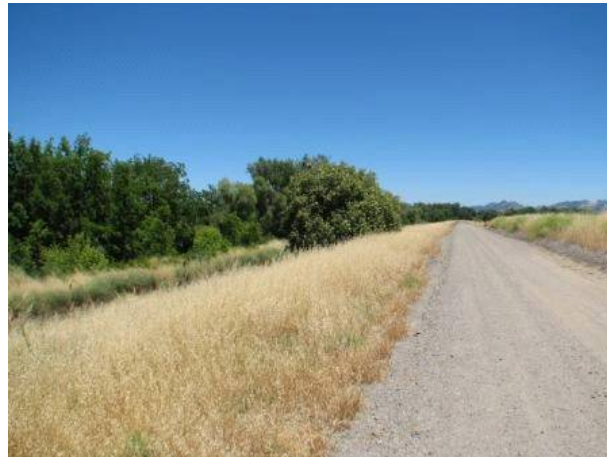
Levee Mile Report Line	3
Start Levee Mile	1.98
End Levee Mile	1.98
Location	Land Side
Category	Earthen Levee
Item	Vegetation

View of the elderberries along the landside toe of the levee.

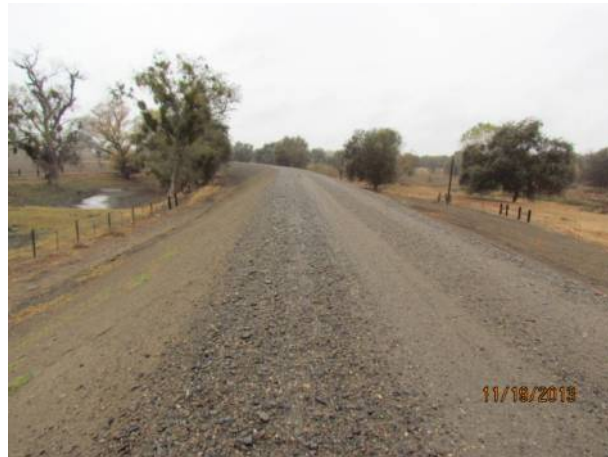
Levee Mile Report Line	2
Start Levee Mile	0.18
End Levee Mile	0.18
Location	Land Side
Category	Earthen Levee
Item	Vegetation

View of the both slopes burned and dragged.
